**DURABILITY OF POST-TENSIONED  
CONCRETE BEAMS EXPOSED TO  
SEVERE NATURAL WEATHERING**

**Edward F. O'Neil**

**U. S. Army Engineer Waterways Experiment Station  
P. O. Box 631, Vicksburg, Miss. 39180**

**April 1982**

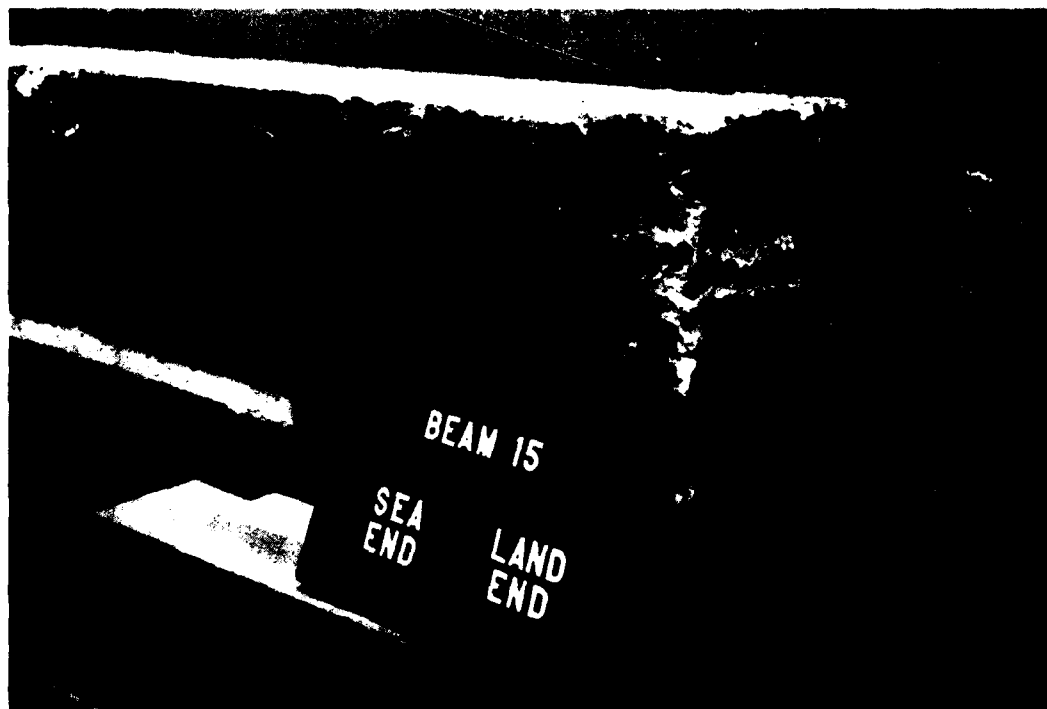
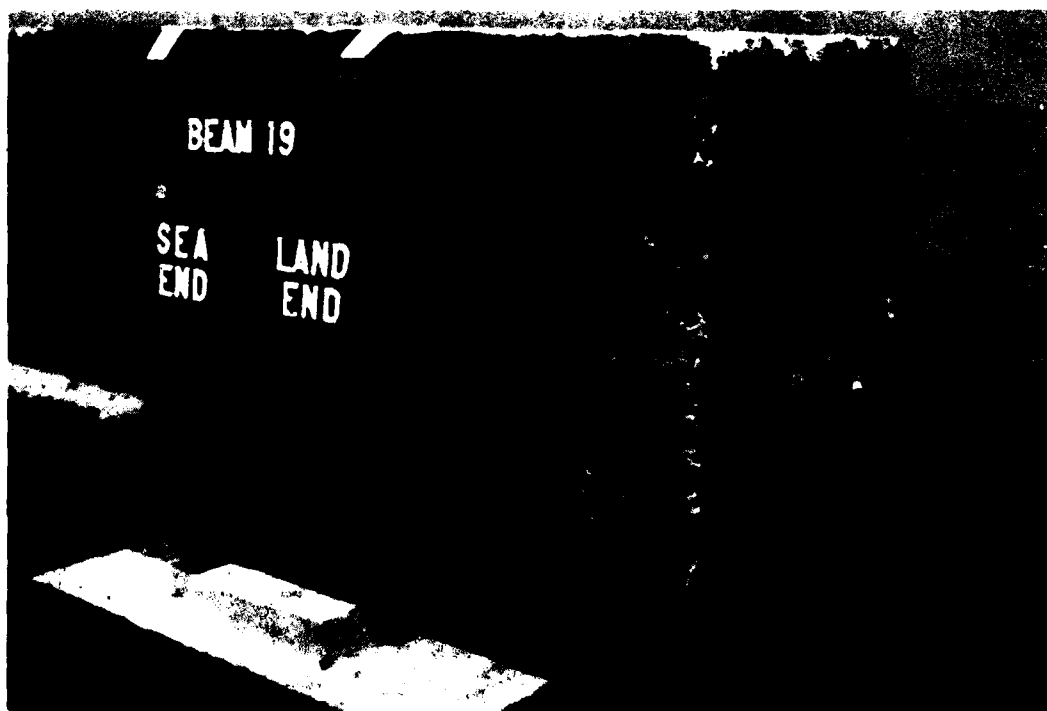
There did seem to be a correlation between the ability of an end cap to resist the forces of freezing and thawing and the sizes of the end anchor. Figure 2 shows the as-received condition of four of the end caps on Beams 15 and 19. The anchorages of Beam 19 were flat compared to those of Beam 15 and both the caps of Beam 19 were missing when returned to the laboratory. All the anchorages that had lost their end caps in this investigation were shallow in depth. In other words, the deeper an end anchorage is, the better its end cap will remain attached throughout any exposure period. This does not mean that the end anchorage will be well protected; however, if the end cap does pry loose, it has been determined that greater corrosion will occur on the steel. In this respect the depth of the end anchorages acted as reinforcement similar to the beams that had reinforcing bars running between the beam itself and the cap over the anchorage. Of the 40 joints on the 20 beams of the study, twelve had reinforcement between the beam and cap and none of these caps pried loose or cracked during the 12 to 13 years of exposure.

FIG. 2—Typical conditions of the end anchorage protection as returned from the exposure site.

FIG. 2—Continued.
